## Preservation Profile: The First Universalist Church, Southold, New York

"Yankee Ingenuity and Common Sense"

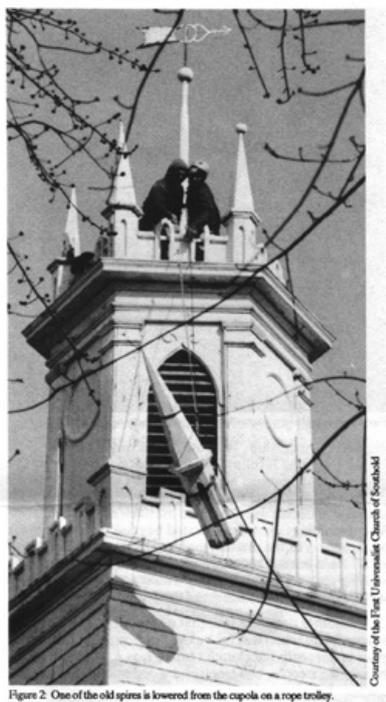
Figure 2. One of the old spires is lowered from the cupola on a rope trolley.

The combined knowledge and skills of the multi-talented people who served on the Committee made the project a success. For example, Ros Corey, a craftsman who had retired to Southold, offered to reproduce the six hexagonal spires and connecting railings that surmounted the belfry. With a few volunteers, including a certified cave rescuer and knowledgeable rope rigger, we set out to bring down the old spires on a rope trolley set up between the steeple mast and an old maple tree in the church yard. The spires glided down easily, as planned, impressing bystanders and press photographers (who gave us a full-page spread in the local papers). A week later, Ros, working from one of the dismantled rotten spires, presented us with a complete and perfectly accurate reproduction of one of the steeple spires, crowned with a cedar sphere. We quickly learned that his woodworking skill was matched only by his energy. He worked through the winter in his basement shop and completed all six spires and connecting rails that form a hexagonal crown atop the belfry. After finishing this task, he also volunteered to restore and gold leaf the weather vane.
